DEFECTS AND FAILURES OF SOVIET STRUCTURES

REPORT NO. 94

Air Information Division, Structural Engineering Section

April 1958

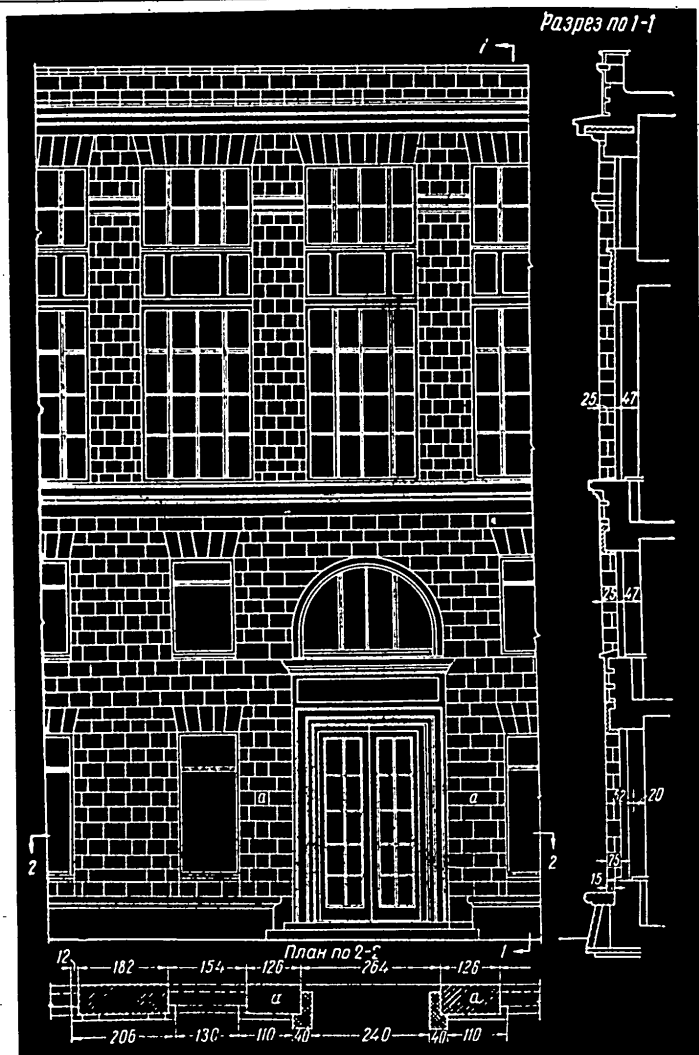
Fig. 2.
Plan
Section 2-2

Fig. 3.
Vertical section;
Section 1-1

Plan, front elevation and section of the part of the wall that collapsed

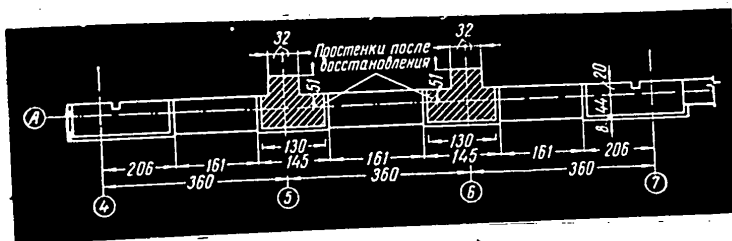
Fig. 2. Reconstructed wall piers. Plan of the 1st floor

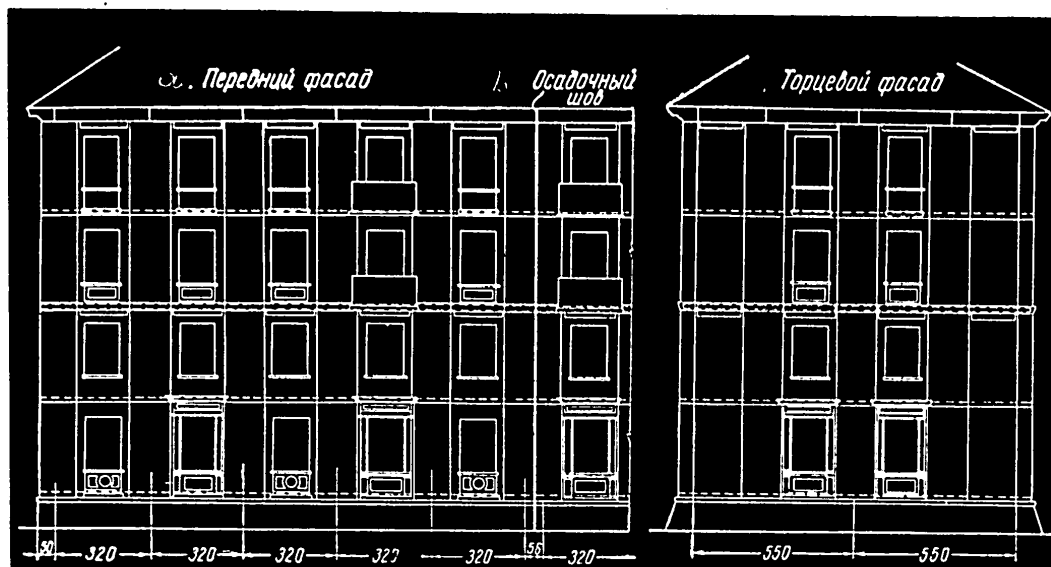
Front and side elevations of the structure are shown on Plate 12, fig. 1.

Fig. 1. Front and end elevations of the structure
a. Front elevation. b. Settlement joint. c. End elevation

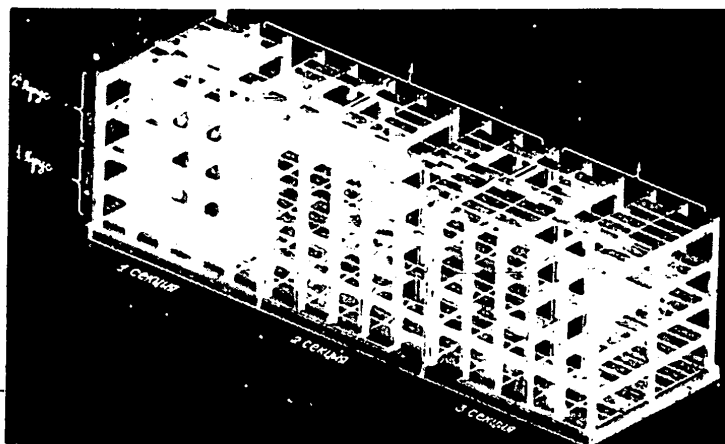
Isometric view of the building is shown on Plate 12, fig. 2.

The immediate cause of the accident was ascribed to the force of wind from the west which, as reported by the Voroshilovgrad airport meteorological station, reached the velocity of 14 - 18 m./s. (31 - 41 mph) on that day.

The real cause, however, should be sought somewhere else.

Fig. 2. Isometric view of the structure at the time of collapse

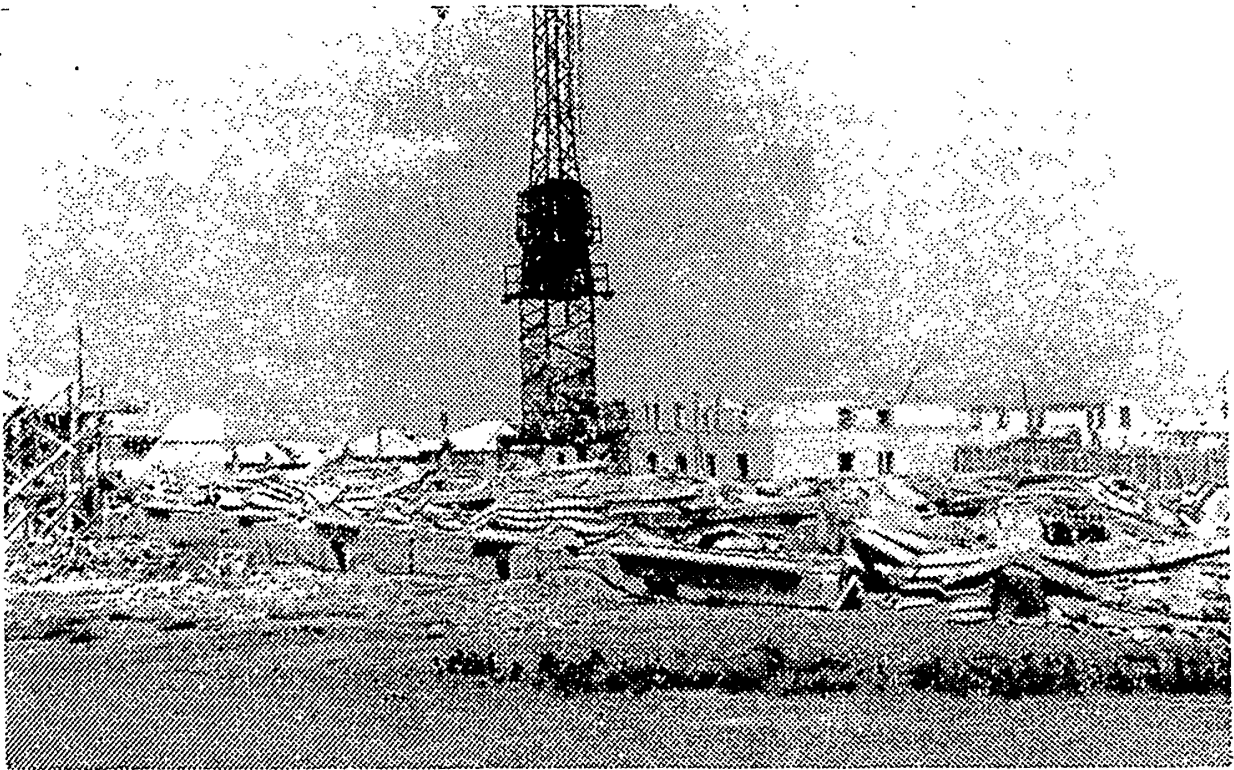
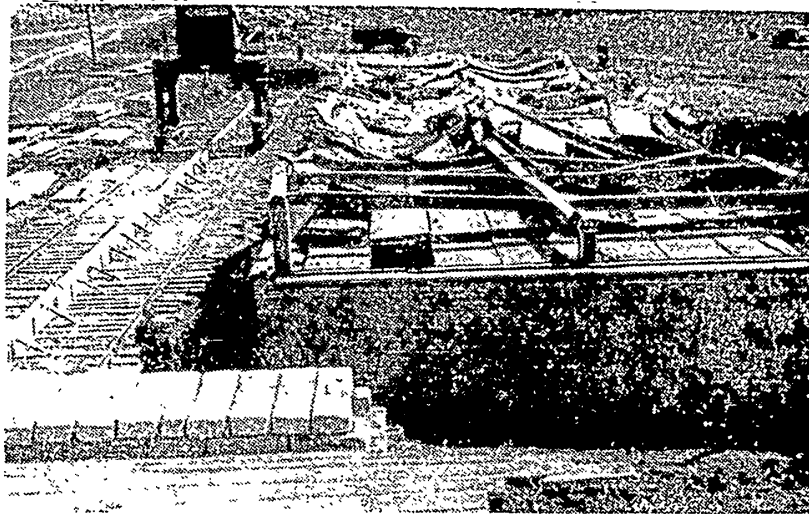
Fig. 1. View looking toward the front wall

Fig. 2. View looking toward the end wall

GENERAL VIEWS OF THE DEBRIS AFTER THE COLLAPSE OF THE RESIDENTIAL
STRUCTURES BY THE MIKHAYLOVSKAYA MINE No. 12
(Captions in the original seem to be interchanged)

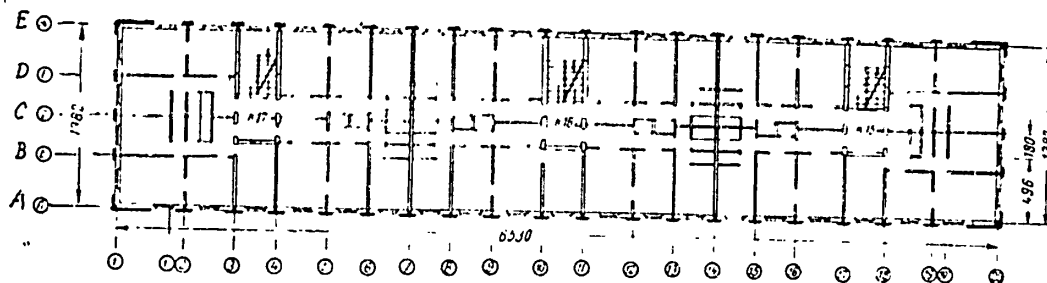
Fig. 1. Plan of the structure

On 25 May 1956, first cracks were noted in the walls of the cellar. In the external wall (between axes 1-4, Plate 14, fig. 1), they were vertical and 5mm. (0.2 in.) wide; in the interior wall (between axes 1-4 and C) they were horizontal and also 5mm (0.2 in.) wide. Numerous cracks, up to 2mm (0.08 in.) in width, were discovered in the panel joints but none in the body of the panels.

On 6 July 1956, extensive damage was observed (along axes 3 and 4, Plate 14, fig. 1) in vertical joints of the external and internal walls as well as in the transverse joints of the floor slabs. The joints of the cornice panels widened to 30 mm. (1.2 in.) beyond the clearance allowance (Plate 15, fig. 1). Inspection disclosed that reinforcement was torn out of concrete, and that the 1.2 in. gap in the cornice corresponded to a 1.2 in. crack in the attic floor slabs. Similar damage was observed in the panel joints of both longitudinal wall and partition. Attic floor slabs (along 3 and 4) moved apart a distance of 20 - 25 mm. (0.79-0.98 in.) This may be explained by the fact that reinforcement projections, i.e., the rods joining the adjacent floor slabs together, did not coincide; being placed under an angle they could not prevent the separation of the panels, (Plate 15, fig. 2).

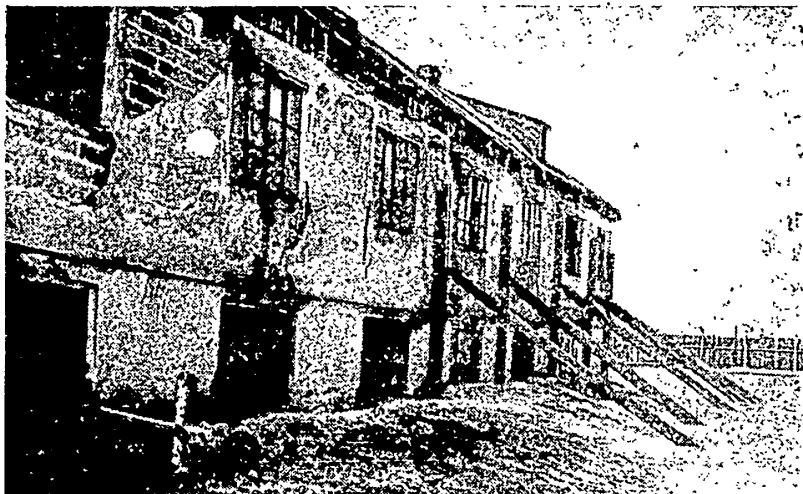
Fig. 2. Lime-diatomite block structure in Sverdlovsk 25 years after erection (strength of hollow blocks: 85 lb/in²)

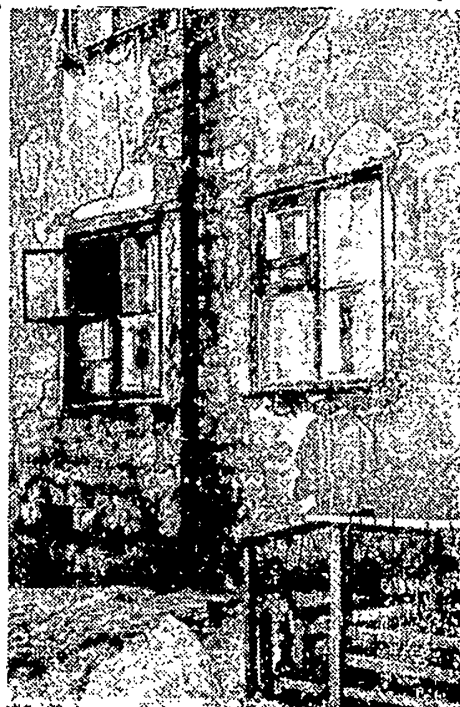
Fig. 2. Disintegration of the walls under the windows and around the drain pipe (strength of the blocks in the fire wall: 298-425 lb/in²)

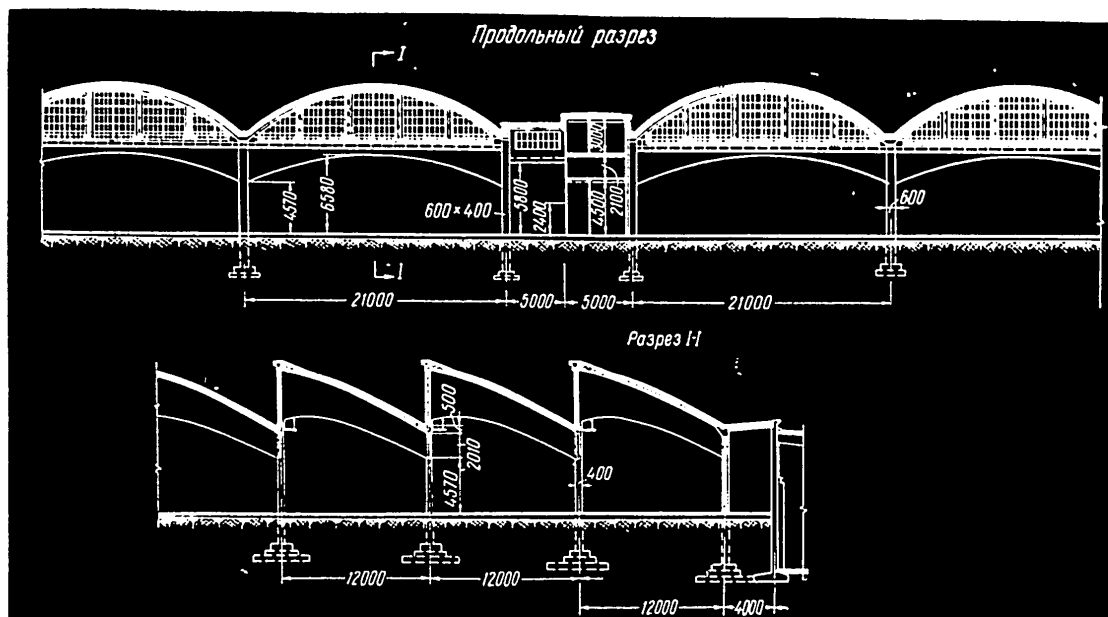
Fig. 2. Transverse and longitudinal sections

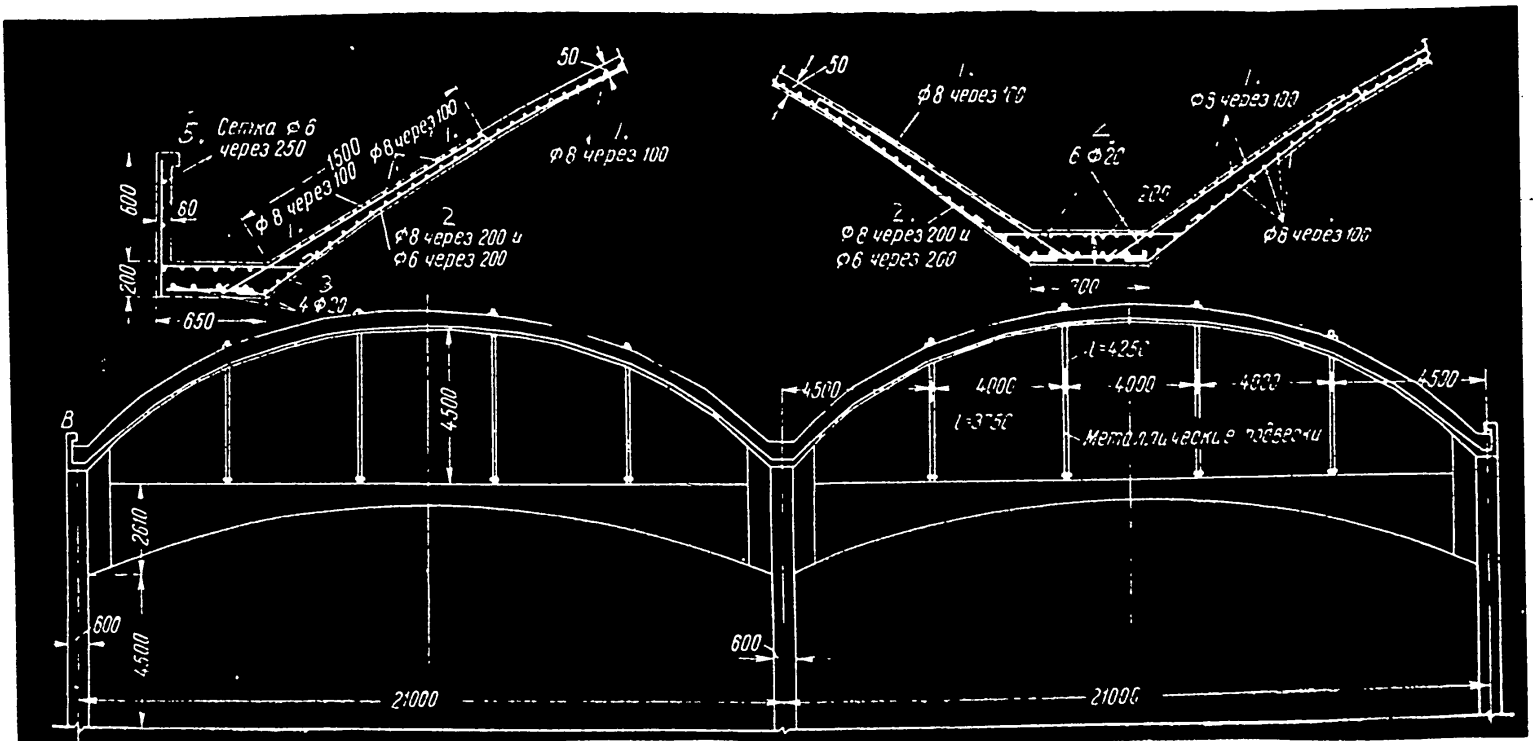
4. The shell reinforcement consists of a single row of 8 mm (0.315 in.) steel rods spaced at 100 mm (3.94 in.) in the middle of the shell and of a double row at the edges. The rods are laid individually and fastened in the concrete form of the shell. Shell reinforcement distribution is indicated on Plate 27, figs. b and c and Plate 28, figs. a and d.

Fig. a. Transverse section

Transverse Section and Side Member-Shell and Middle Member-Shell Joints

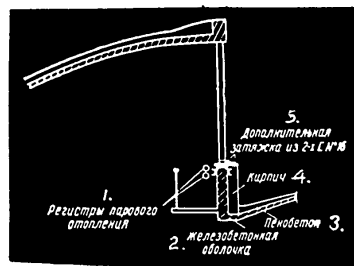
Fig. 2. Heating arrangement that speeded collapse
 1. Pipe heaters
 2. RC roof shell
 3. Foam concrete
 4. Brick
 5. Additional tie beam (2 - No. 16 steel channels)

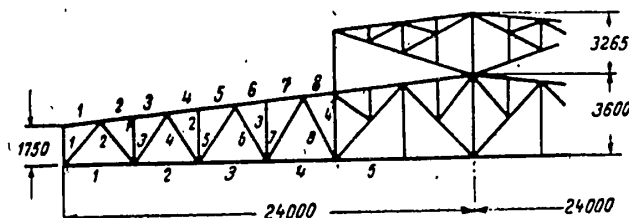
23.6 in. buckling occurred in web diagonal No. 8
